MODELING OF TOMB DECAY AT ST. LOUIS CEMETERY NO. 1:

THE ROLE OF MATERIAL PROPERTIES AND THE ENVIRONMENT

A THESIS

Historic Preservation

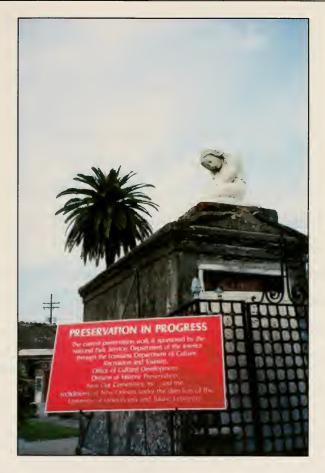
Fig. 2.10 Bergamini Tomb #12, One of the SOC pilot restoration tombs. Photograph by Studio, March 2001.

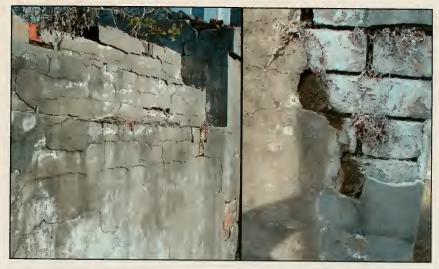
Fig. 4.5 Telescoping brick wall.

Fig. 4.6 Open mortar joints and evidence of wetness

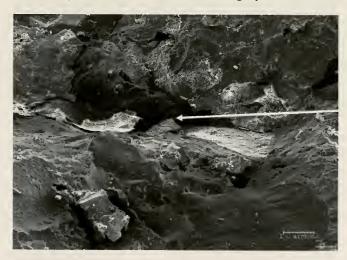
The next series of SEM images focuses on the interface between the Dark Tan and Gray layers of Tomb #200. In the first image at 100 times magnification, microcracking at several places along the bond can be seen. The earlier Dark Tan layer is at the top of the image and the newer gray layer is at the bottom. Close to the interface between the two materials, a pore in the Tan layer shows re-crystallized calcite. This can occur if the tan layer is kept wet near its surface by the Gray layer. When wet, the calcite from smaller pores slowly goes into solution and moves towards the surface, recrystallizing once the water dries out in the larger pore.

Fig. 5.48 Tomb #200, Interface between Dark Tan (top) and Gray (bottom) Stucco Layers, 100x. Note cracks and air spaces at the interface.

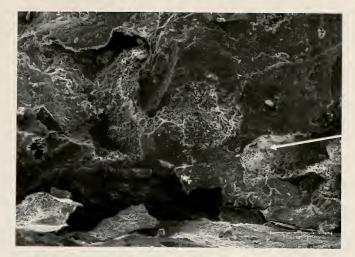
Fig. 5.49 Tomb #200, Interface between Dark Tan (top) and Gray (bottom) Stucoto Layers, 250x Note pores with recrystallized calcite.

Fig. 5.50 Tomb #200, A highly magnified view of a pore with re-crystallized calcite, characterized by soft, rounded crystals, 1000 x.

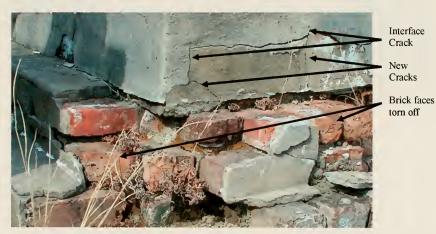
Fig. 6.10 Tomb #558 was originally covered in Tan stucco and has been patched with Gray (cement). When the Gray layer failed, it cracked at the interface with the original stucco, forcing new cracks into that layer, and tore off the brick faces wherever it was directly adhered. In some cases the released stress caused the pulling out of the entire brick. The missing bricks in the image above were found on the ground about the tomb with the cement stucco still firmly attached.
